Loose Torque Rod Locknuts Cause Deadlines

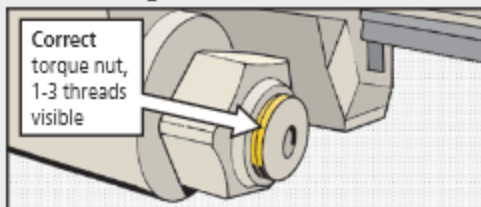
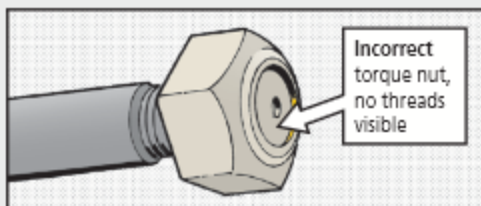
Check for Extending Threads

Immediately inspect your FMTV LTAS 6X6 truck and M1095 trailer to see if each torque rod nylon insert locknut has threads that are visible beyond the locknut. A properly tightened nylon insert locknut will show 1-3 threads exposed past the nylon lock feature.

You won't see extending threads if the locknut is improperly torqued. That means your truck or trailer is non-mission capable (NMC) until all the nylon insert locknuts have been properly torqued.

For your FMTVA1P2 LTAS truck, use the maintenance instructions found in the Rear Torque Rod Replacement work package of TM 9-2320-333-14&P (EM 0294, Jun 12). And for your M1095 trailer, refer to the maintenance guidance in WP 0097 of TM 9-2330-394-13&P.

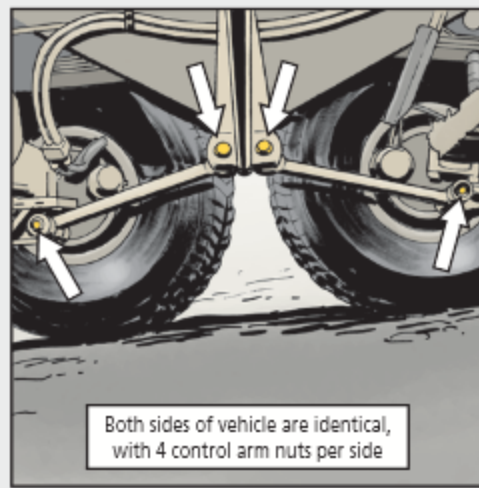
Color Coding

If blue torque seal markings have been applied to all eight locknuts, Oshkosh has already inspected the vehicle. If your truck or trailer serial number is within the ranges we gave you earlier, and your unit hasn't given a status report, make sure you follow the guidance in TACOM SOUM 12-015 and TACOM SOUM 13-005.

See any green or blue markings on the locknuts? Then your truck or trailer is good. But if you don't see these marks, a green mark is needed after your vehicle gets a passing inspection, or when corrective actions have been completed. Mark each torque rod nylon insert locknut with a small green marking.
